Module 10
Common fault areas in separating floors

Welcome to Module 10 – Common fault areas in separating floors

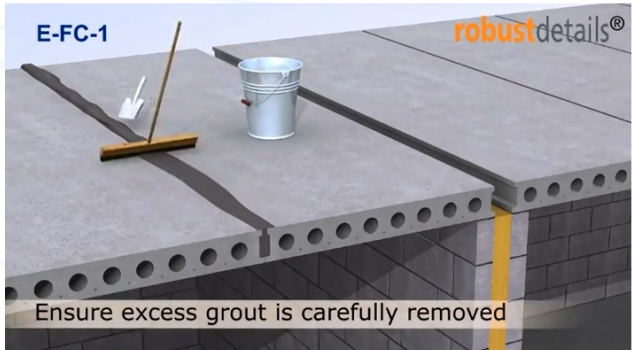
Ensure all slab joints are fully grouted.

Open slab joints can allow the passage of high frequency noise.

Remove any excess grout to prevent damage to the resilient layer.

Ensure all joints and gaps in the planks are fully grouted. This enhances the floor stiffness, and stops the passage of high-frequency noise.

It is not acceptable to use expanding foam instead of grout.

It's important to remove the excess grout before it sets; and make sure the floor surface is clean before laying the resilient layers, to avoid any damage.

This is a still from one of the many animations we have on the Robust Details website – they're definitely worth a look if you're working with an unfamiliar Robust Detail.

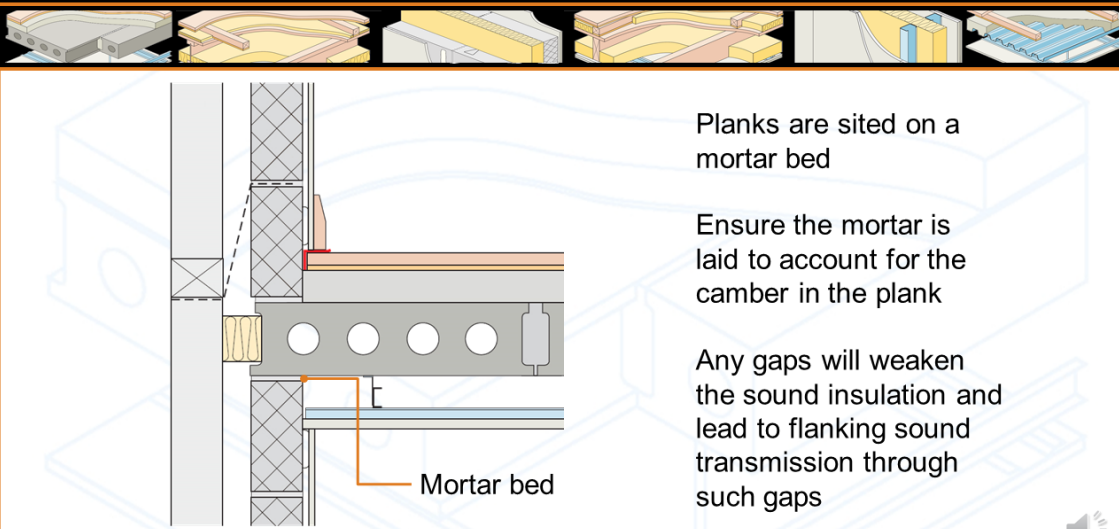
Planks are sited on a mortar bed

Ensure the mortar is laid to account for the camber in the plank

Any gaps will weaken the sound insulation and lead to flanking sound transmission through such gaps

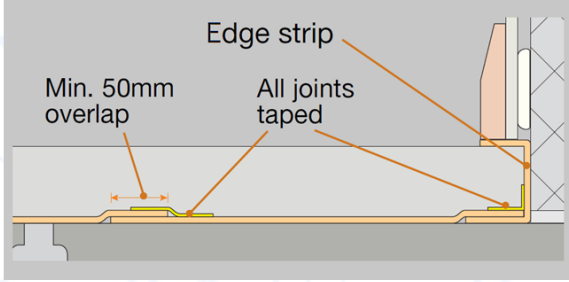
Resilient layers **must** be installed allowing for the **required minimum overlaps**

All **joints must be taped** to prevent relative movement of the components

Edge strips are also referred to as flanking strips

It is critical that the resilient system, comprising the resilient layer and flanking edge strips, are properly installed with the required overlaps – and tape is securely applied.

Overlapping and taping the joints guards against the material moving during the screeding process. If it does move, the screed can get into any gaps that are formed, and will create a flanking path.

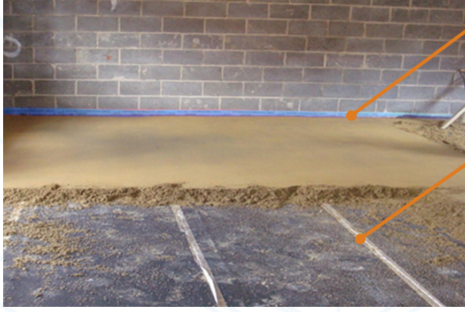
Correctly installed resilient layer

Flanking strip installed around whole perimeter and extended up wall to prevent screed touching walls.

Isolating layer laid flat over floor with **OVERLAPPING** and **TAPED** joints

This is a photograph shows correctly installed resilient layer remaining firmly in place during application of the screed.

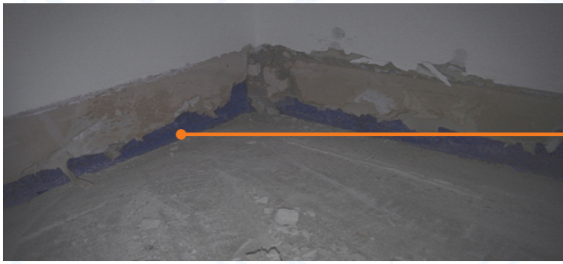
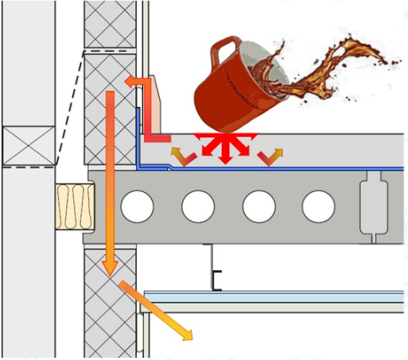
Investigations identified that the 'weakness' was associated with the perimeter detailing of the floating screed finish.

During the Robust Details monitoring, an impact fail was recorded – and the weakness was narrowed down to the perimeter.

By removing the skirtings, it was found that although the resilient flanking strips had been installed they had not been dressed down over the top of the screed. As this image, shows, the contact of the skirting/wall finish onto the screed creates a flanking path, which in this case was sufficient to undermine the test results.

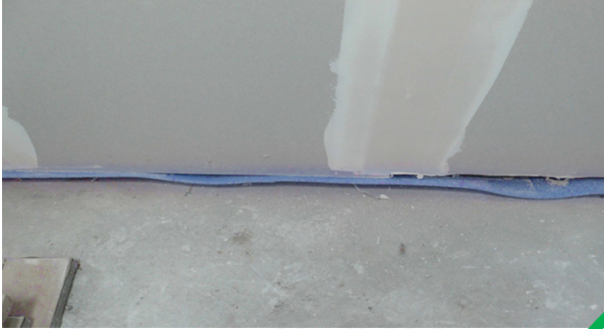
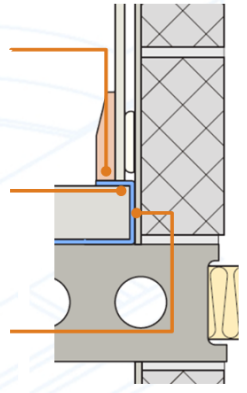
Flanking strip ready to receive the skirting board.

Skirting isolated from screed

Gypsum board and dabs do NOT come into contact with screed

Flanking strip dressed up wall and over the edge of the screed ready to be cut back to skirting and seal

Resilient flanking strip must be dressed up the edge and over top of floating screed. This will isolate the screed from wall linings; and when the skirting board is affixed to the wall, it will sit above the flanking strip – and not on the screed.

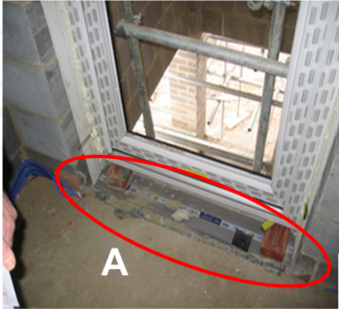
A

Flanking strip missing at junction between screed and balcony door

In picture (A) the flanking strip is missing at junction between screed and balcony door. Sound and vibration will now be able to transmit into the block walls and door cill.

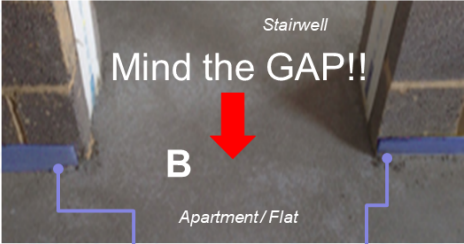
B

Mind the GAP!!

Perimeter edge strip or flanking strip **should have been continuous across the door opening** to isolate screed from stairwell landing.

In picture (B) the screed has been allowed to connect and touch directly through to the common stairwell landing of the flats and also comes into contact with the block walls.

The purple perimeter edge strip or flanking strip should have been continuous across the door opening to isolate the screed from the stairwell landing.

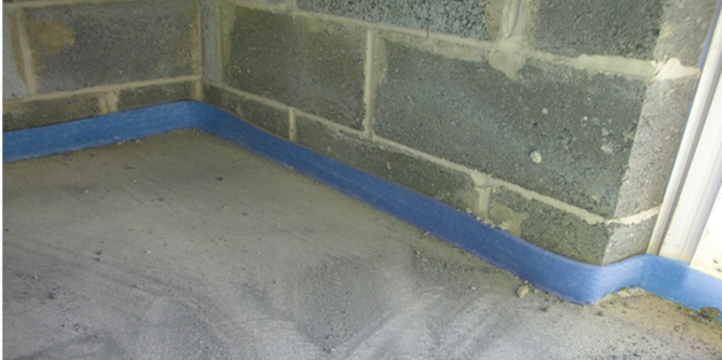
Good isolation of screed by resilient flanking strip

Flanking strip properly installed around the perimeter – just remember to fold it down before applying the wall finishes.

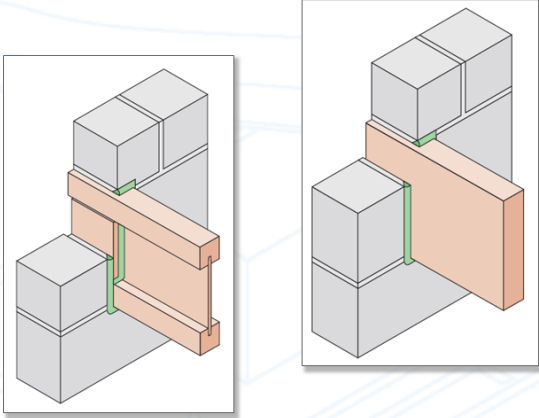
Timber separating floors cannot be used with masonry walls.

They do not break the flanking path like concrete floors would.

As stated at the top of page 1 of each of the timber separating floors, they are for “Use with timber frame walls only”.

If used with masonry walls, they will allow flanking sound via the masonry leaf that is continuous past the edge of the floor.

Concrete floors are built into all of the surrounding walls which fully breaks this flanking path – timber joists only give small intermittent breaks at best.
